# STRUCTURAL FAILURES

investigating failures, along with their consequences and resolutions

## Failure of Imagination

By Stan Caldwell, P.E., SECB

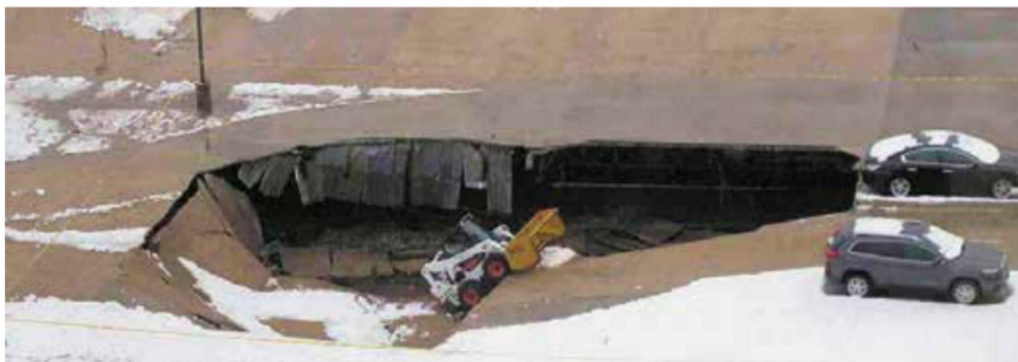
Saturday, 01/24/15, Secaucus, NJ

Failure caused by compacted snow pile, Secaucus, NJ.

A 3-level garage with 600 parking spaces serves the Harmon Plaza office tower, the Clarion Empire Meadowlands Hotel, and the Osprey Cove apartments. A Bobcat utility vehicle was plowing the top deck of the garage following a snowfall of 4 inches or less. The weight of the Bobcat was not a problem, nor was the weight of the accumulated snow. However, compacted snow weighs about 20 pcf, and 30 pcf or more if wet.

The snow had been pushed into a compacted pile. At 7:00 am, with the pile more than 4 feet high, the top deck of the garage collapsed under the combined weight of the snow pile and the Bobcat. The resulting opening swallowed the Bobcat and one vehicle parked below was crushed. No one was injured except the Bobcat driver, who had a mild concussion. On weekdays, the garage would have been filled with vehicles and people.

In Secaucus, the garage probably did not need to be plowed. The light snow likely would have melted within a day or two. If snow removal was necessary, it should have been done in a manner that avoided creating compacted piles.

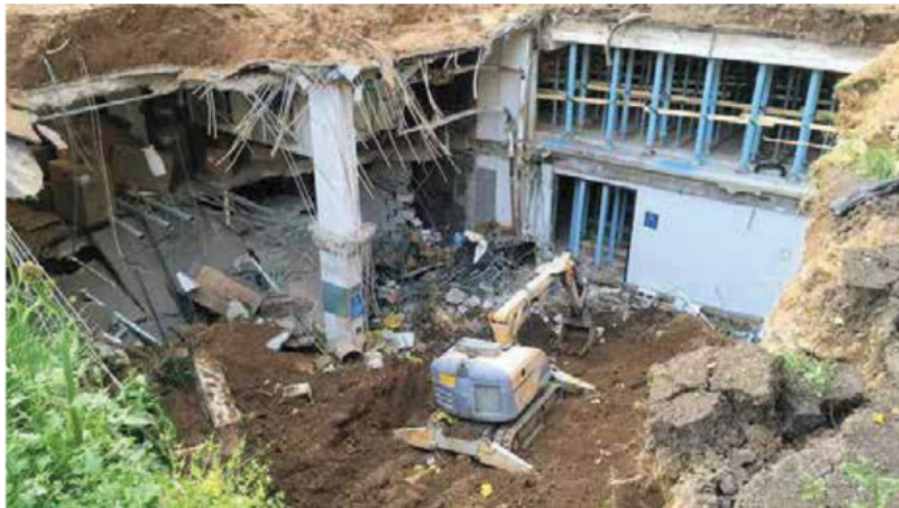
Friday, 05/01/15, Washington, D.C.

A 3-level garage serves the iconic Watergate mixed-use complex. Now more than 50 years old, the complex was undergoing a comprehensive restoration. A landscaping contractor placed soil and debris on the top deck of the parking

Garage collapse, Washington, D.C.

garage. Soil weighs about 75 pcf if dry, and up to 125 pcf if wet. Thus, only one foot of soil might cause failure.

At 10:00 am, the top deck of the garage collapsed beneath the soil and debris. Everything on the two levels below was crushed in a pancake failure. Two people were injured, one critically, and about 35 vehicles were destroyed.

In Washington and Dallas, the owners and the landscaping contractors should have

contacted structural engineers for approval before the placement of any soil or debris, even temporarily, on the top decks of the garages. In Houston, an above-grade security fence or rail at the perimeter of the underground garage footprint would have kept heavy trucks off of the top deck.

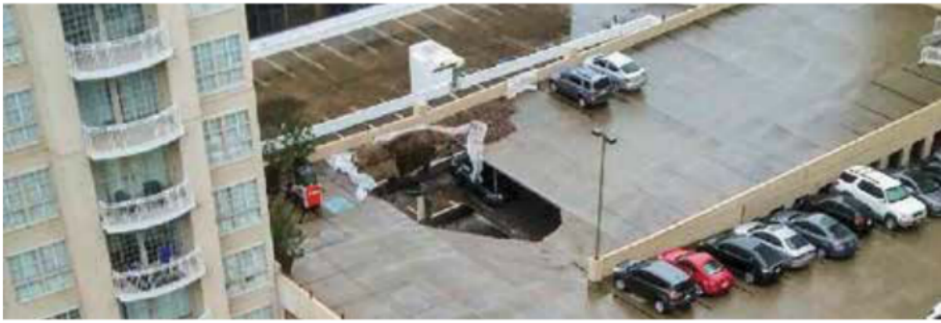
*Friday, 10/23/15, Dallas, TX*

*Pancake failure, Dallas, TX.*

A 7-level garage with 800 parking spaces serves the upscale Renaissance on Turtle Creek condominiums. The pool and amenities deck at the top of the garage were being renovated, and the contractor piled soil and miscellaneous debris at the toe of a ramp near one corner of the top deck of the garage. A video taken just a few hours before the collapse shows that the pile was about 3 feet high and was covered with plastic sheeting.

During a rainstorm, water flowed down the ramp and partially saturated the pile. At 5:00 pm, the top deck of the garage collapsed beneath the pile. Everything on the six levels below was crushed in a pancake failure. Amazingly, no one was injured. Numerous vehicles were destroyed, and about 250 vehicles and their contents remained inaccessible to their owners for 58 days. The garage remained closed for several months until reconstruction was completed.

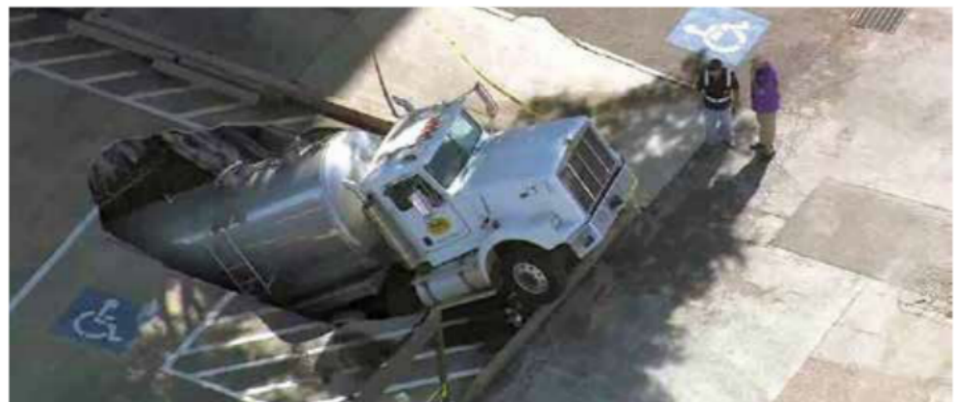
*Friday, 04/22/16, Houston, TX*

An underground garage with an at-grade top deck serves adjacent office buildings on Town & Country Boulevard in Houston. The garage had been flooded during a period of record rainfall. A tanker truck was summoned to the site to pump out the water. The entrance to the top deck was blocked by a clearance bar proclaiming “MAXIMUM WEIGHT 4,000 LBS”, so the truck driver backed his tanker over the curb and onto the deck a few feet to the right of the entrance.

The tanker has a capacity of 5,800 gallons. That amounts to 48,400 pounds of water, not including the weight of the truck. As the tanker filled with water, the top deck

eventually failed under the weight of the rear wheels. Fortunately, no one was injured.

*Deck failure, Houston, TX.*
